Name Of Dam: Lake of the Woods

Location: Orange County, State of Virginia

Inventory Number: VA 13701

PHASE I INSPECTION REPORT NATIONAL DAM SAFETY PROGRAM

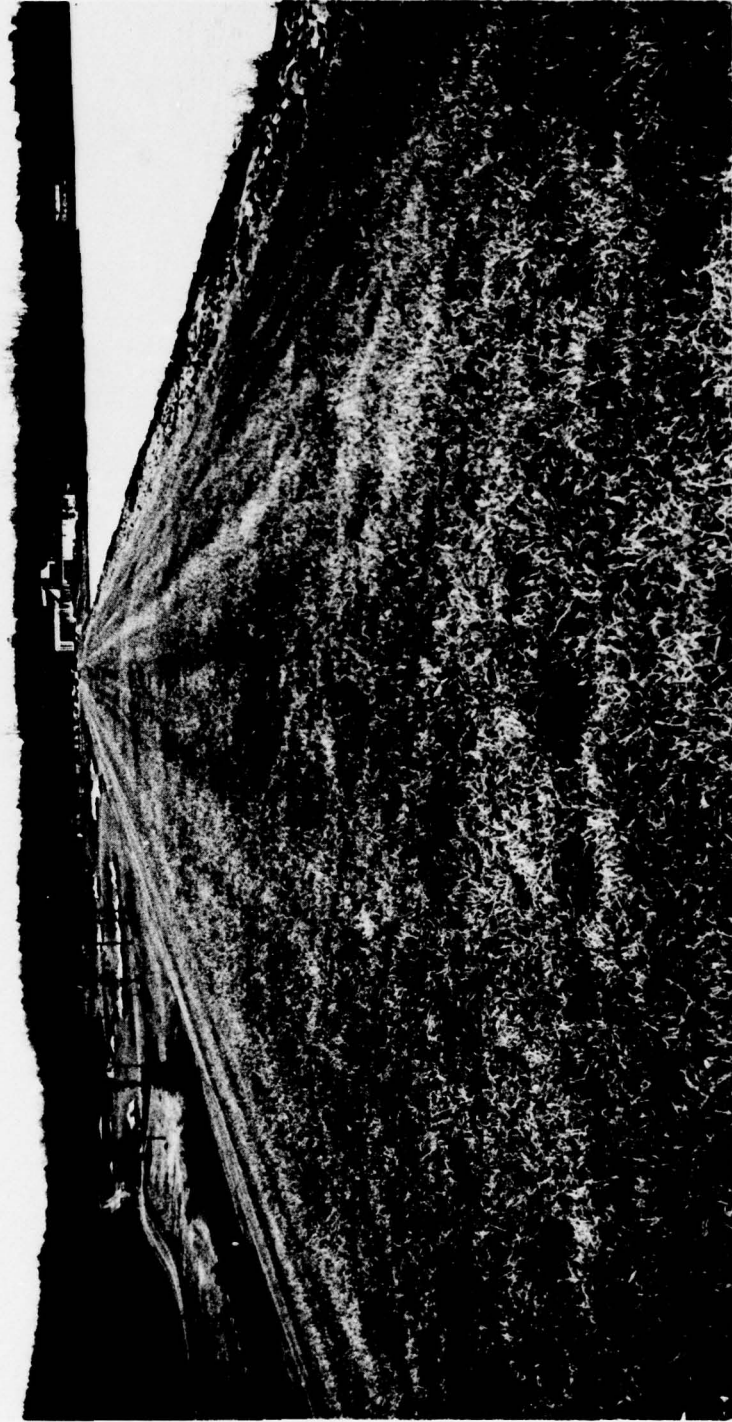
OVERALL VIEW OF DAM
